# Snow Country Ski Club

Smiggins Lodge Building Review -  
UPDATE

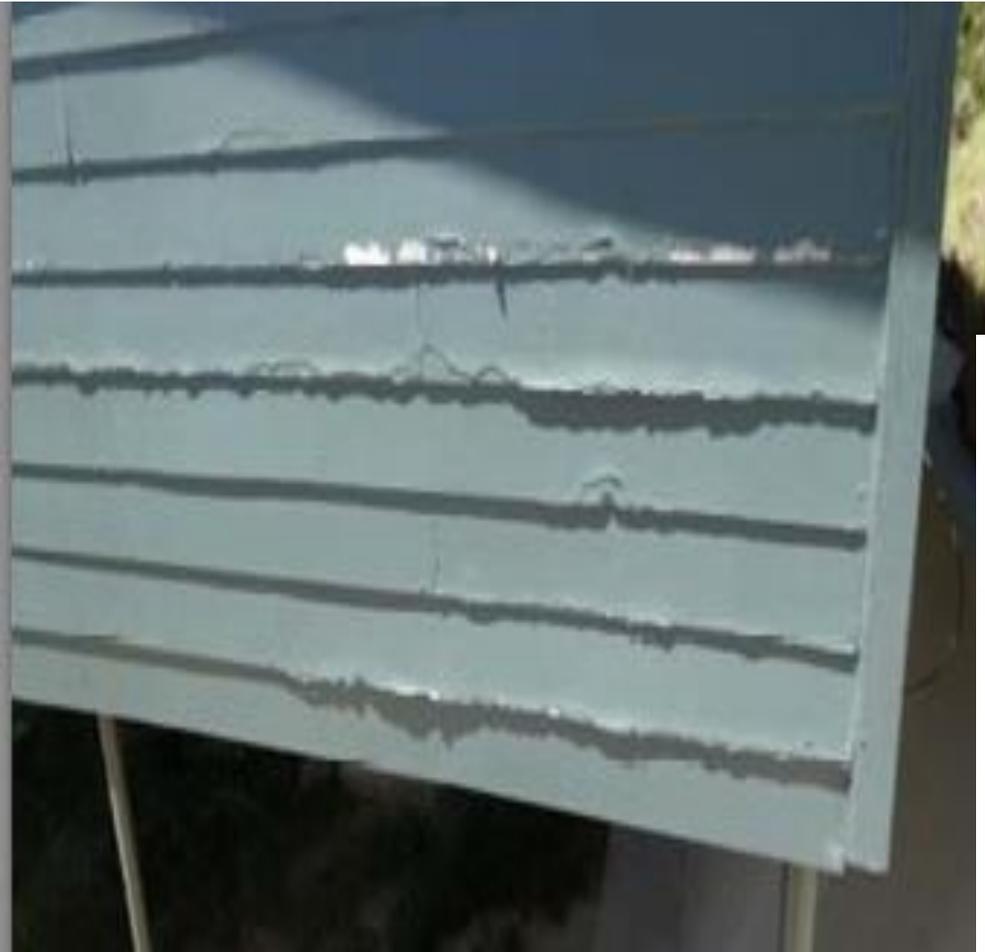
External cladding requiring replacement

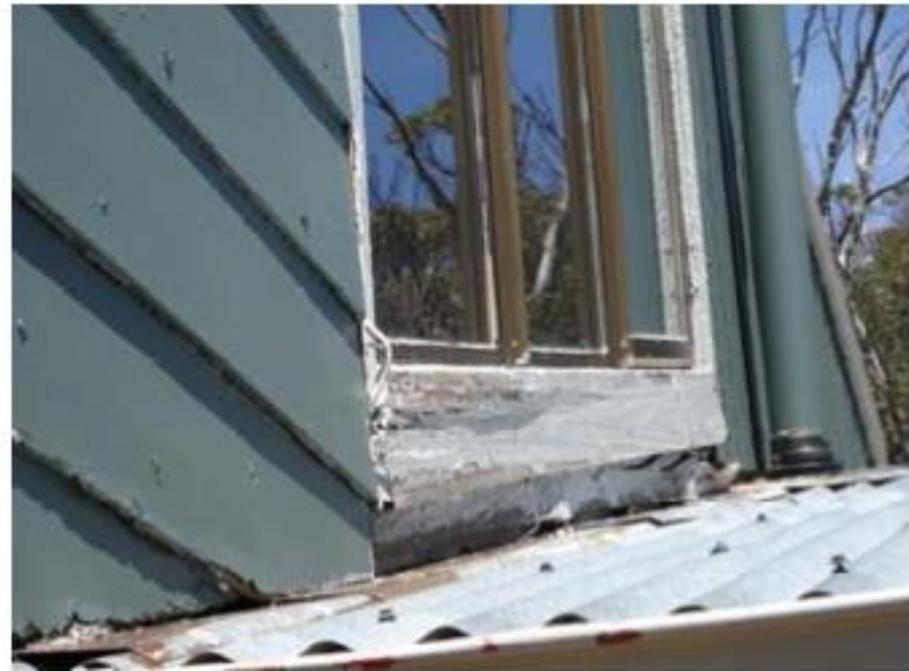
Damaged window trims/flashing causing leaks and rot

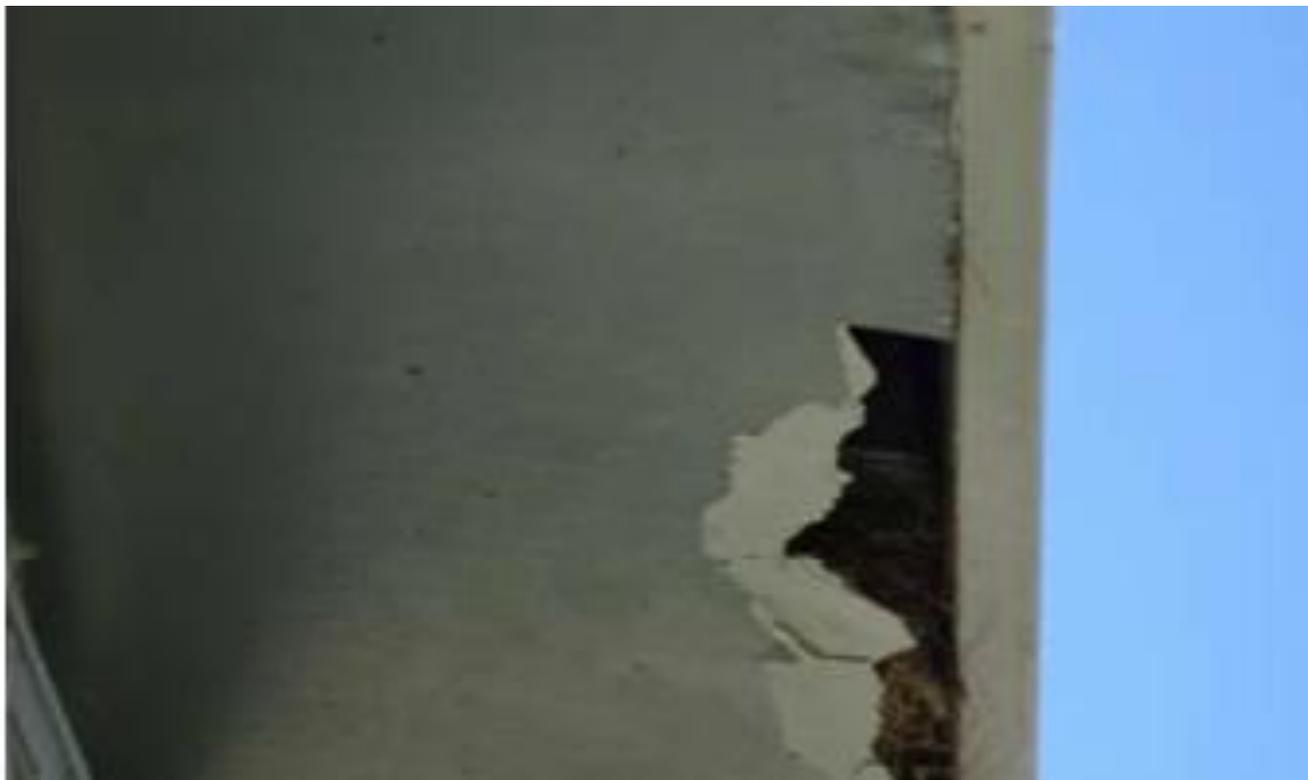
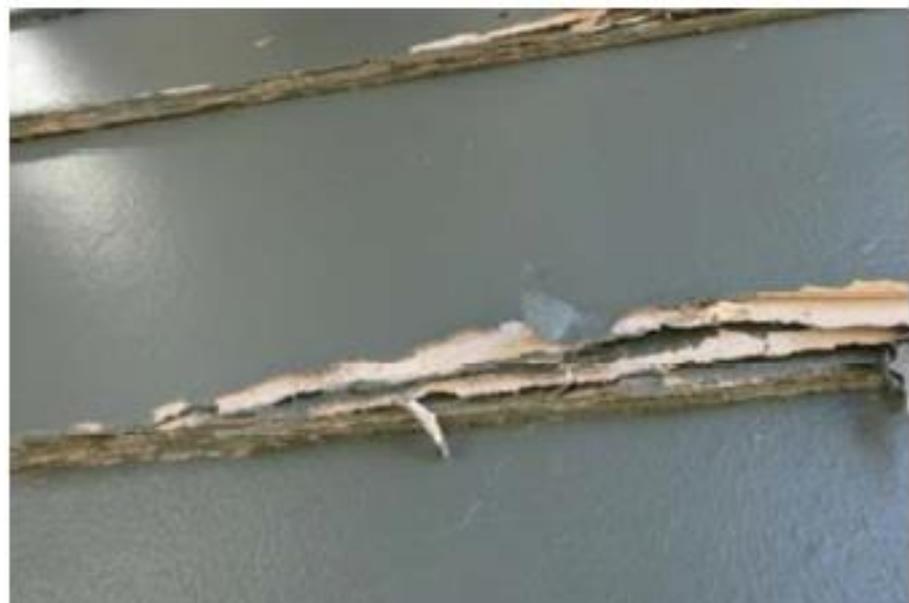
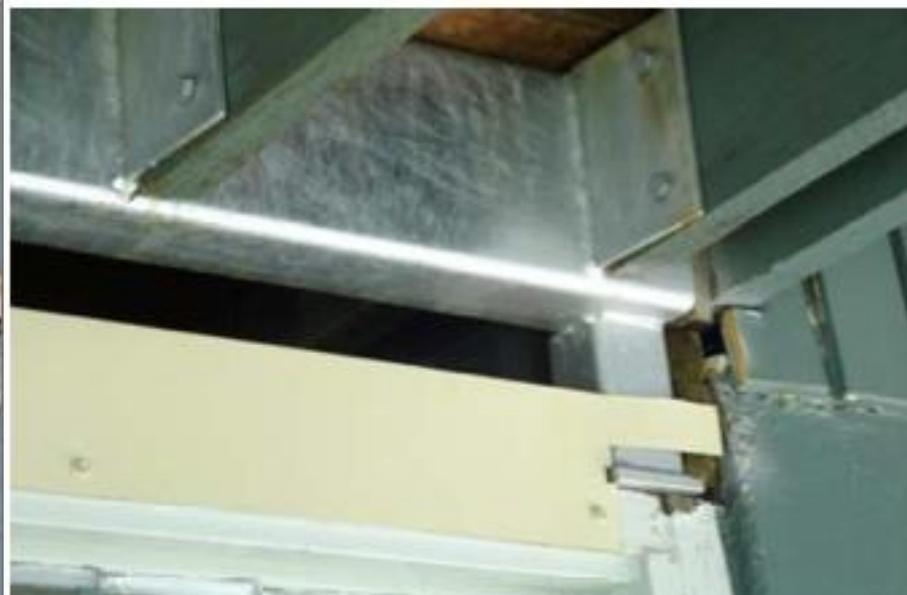
Significant  
damage to eaves
